Madison Sediment and Temperature TMDLs

**Madison Sediment and Temperature
TMDLs and Water Quality Improvement
Plan - Stakeholder Review Draft**

Document Number M06-TMDL-01bD

Madison River Watershed Advisory Group meeting to discuss the stakeholder review version of a draft total maximum daily load (TMDL) document containing sediment and temperature TMDLs for tributaries of the Madison River

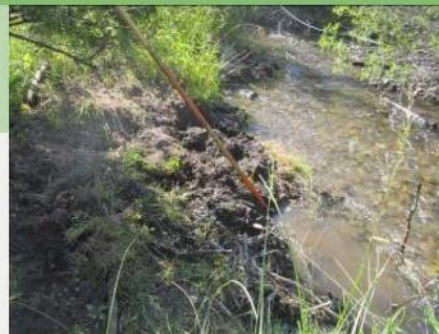
A trampled streambank from cattle access at monitoring site ATLP 04-02

The excess fine sediment loading at the upper DEQ-monitored site (ATLP 04-02) is linked to riparian grazing in the form of trampled streambanks and over-widened areas of the stream from cattle crossings.

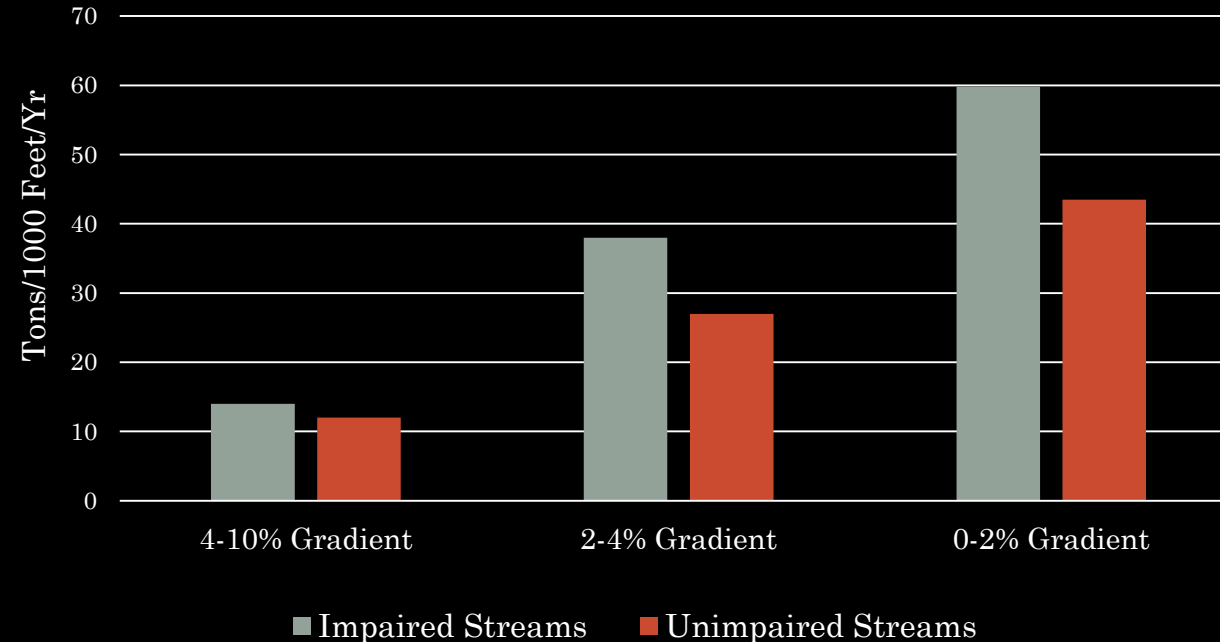
Effects of Gradient and Riparian Condition

- What did unimpaired stream have in common?
 - Average moderate to good riparian quality
 - 75 % of riparian zone in “natural conditions”

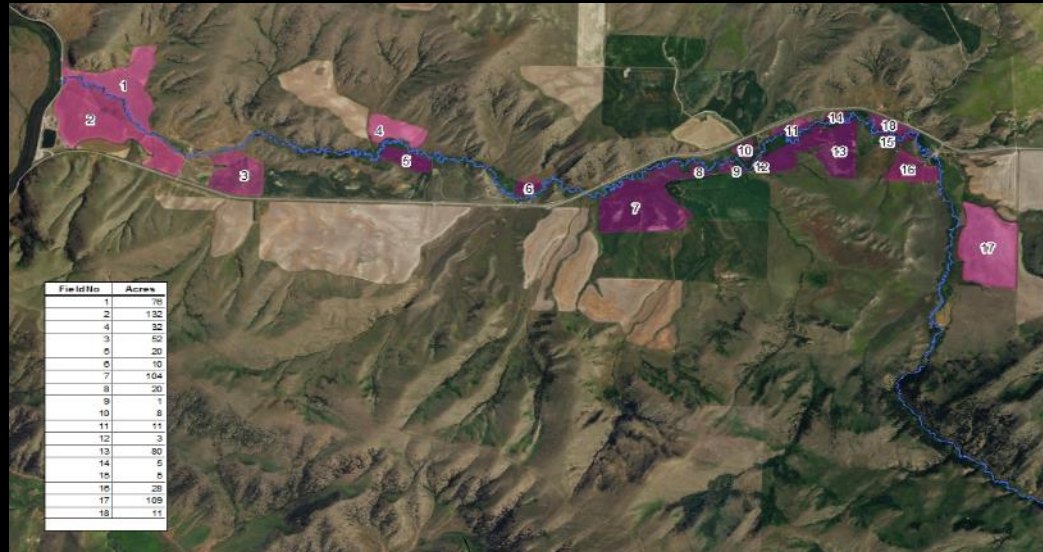
- Most streams were found to have adequate upland conservation practices
- Exception: Elk Creek
- Universal Soil Loss Equation and Riparian Buffer

30%
Reduction if
BMP's Used
