# Red Rock Metals, Sediment, and *E.coli* TMDL Watershed Advisory Group Meeting

March 4, 2021

Red Rock River Watershed  
Advisory meeting to discuss  
results of water quality  
monitoring study and progress  
on Metals, Sediment and E. Coli  
Total Maximum Daily Load Plan

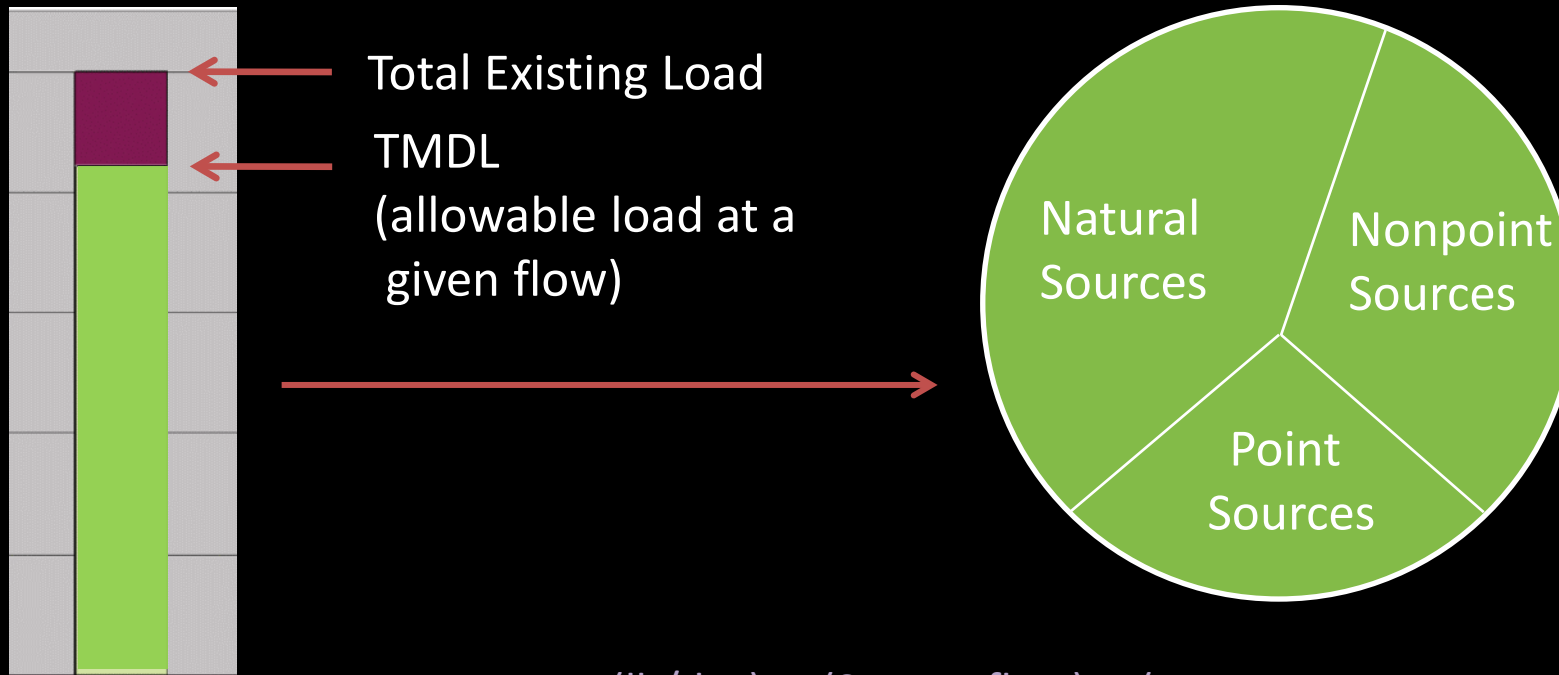
# TMDL Allocations: Conceptual Diagram

$$\text{TMDL (lb/day)} = (\text{Stream flow}) \times (\text{target concentration}) \times (\text{conversion factor})$$

$$\text{Natural Sources} + \text{Point Sources} + \text{Nonpoint Sources} = \text{TMDL}$$

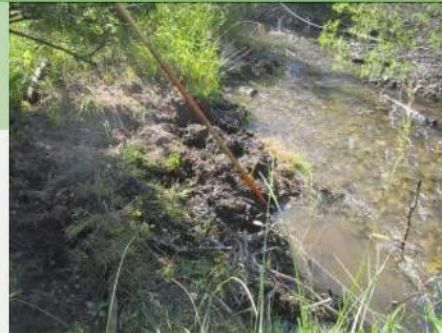
The excess fine sediment loading at the upper DEQ-monitored site (ATLP 04-02) is linked to riparian grazing in the form of trampled streambanks and over-widened areas of the stream from cattle crossings.

A trampled streambank from cattle access at monitoring site ATLP 04-02

Riparian area improvements in the form of grazing best management practices could eventually result in reducing sediment loading enough to meet the water quality standard. The DEQ-monitored site on lower Antelope Creek (ATLP 10-01) demonstrated stable streambanks and a recovering riparian area due to a more recent fencing project and hardened stream crossing that has reduced livestock access to the stream.

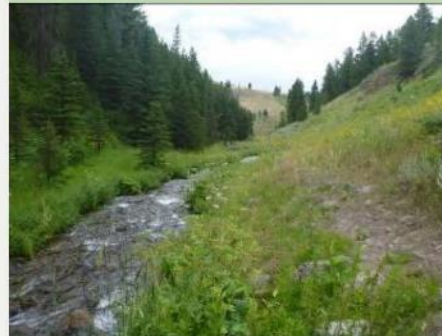
Healthy riparian vegetation along Antelope Creek

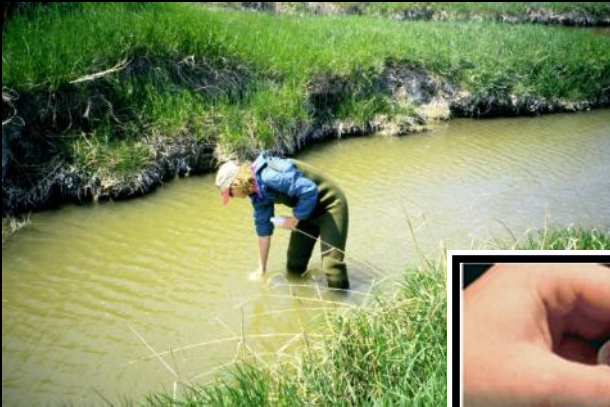
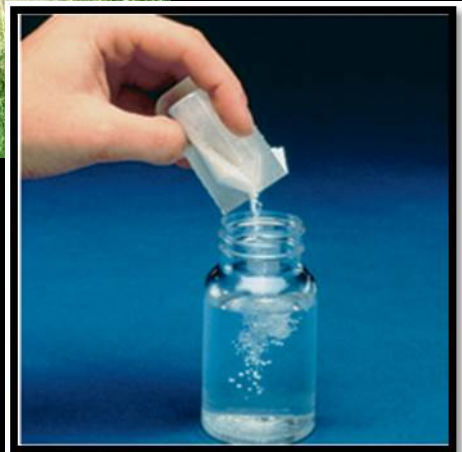
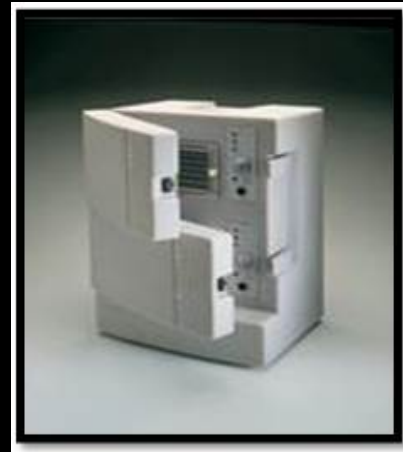
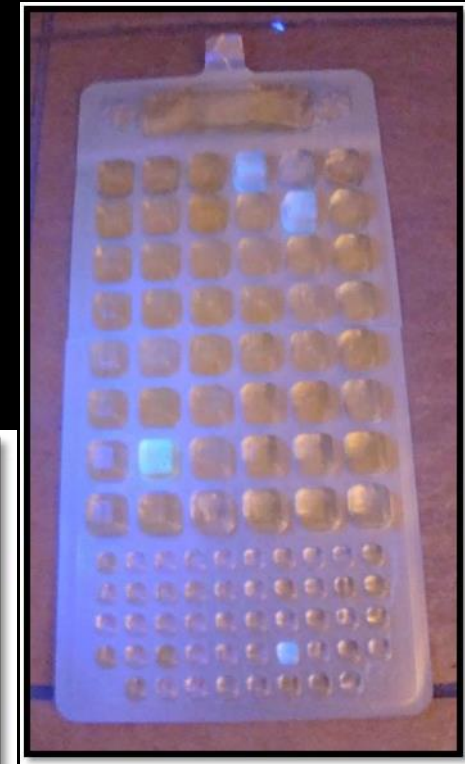
# E. coli Sampling

- Minimum of five samples obtained during separate 24-hour periods during any consecutive 30-day period
- Sample preservation
- Strict holding times, 6 hour handling time and 2 hour processing time.
- Sample incubation
- Sample interpretation
