# Red Rock Metals, Sediment, and *E.coli* TMDLs

Christy Meredith, Lou Volpe

August 10, 2021

# Meeting Purpose

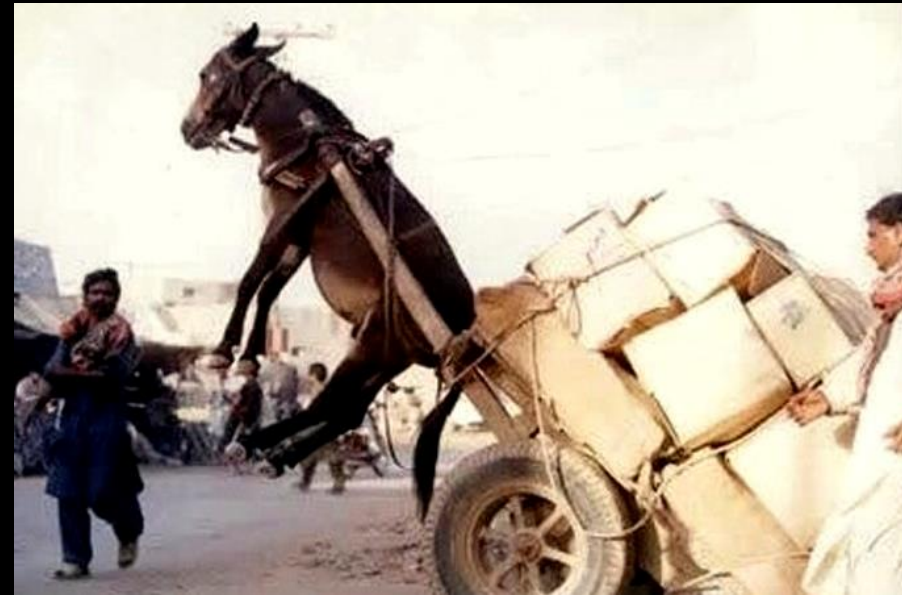
Total Maximum Daily Load is the maximum amount of a pollutant that a waterbody can receive and still meet water quality standards

← Total Current Load

← TMDL  
(Allowable Load)

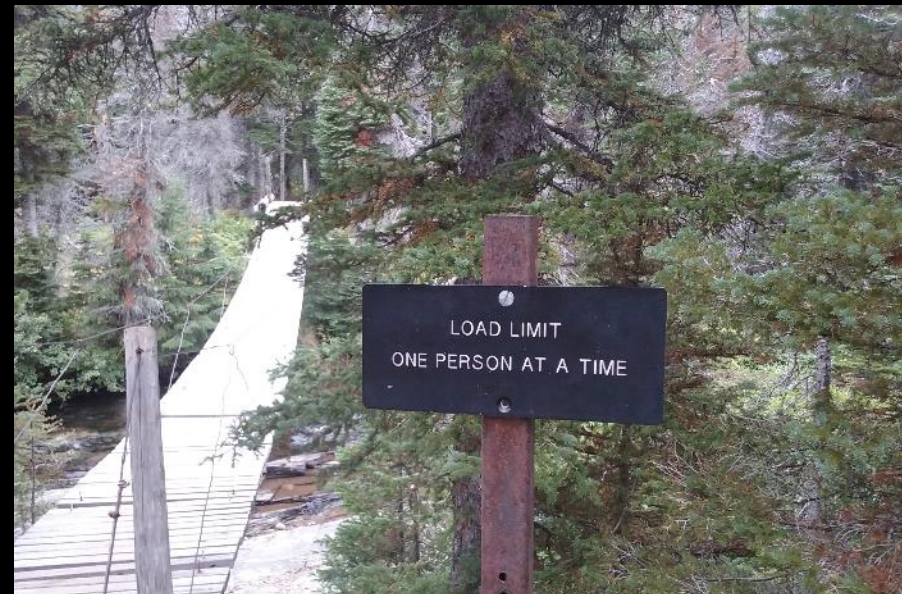
Simple TMDL:

6.8 cfs\*  
10 ug/L Arsenic \*  
0.0054 (conversion factor)  
=0.368 lbs/day

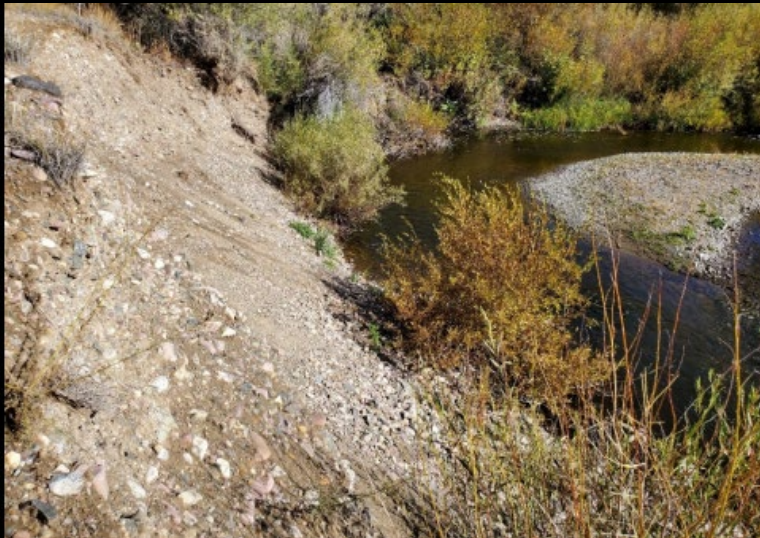
Tailings Piles

- Metals erode from rock when exposed to air and water during mining or other earth-moving activities
- They can bind to sediment and get resuspended later during storm events

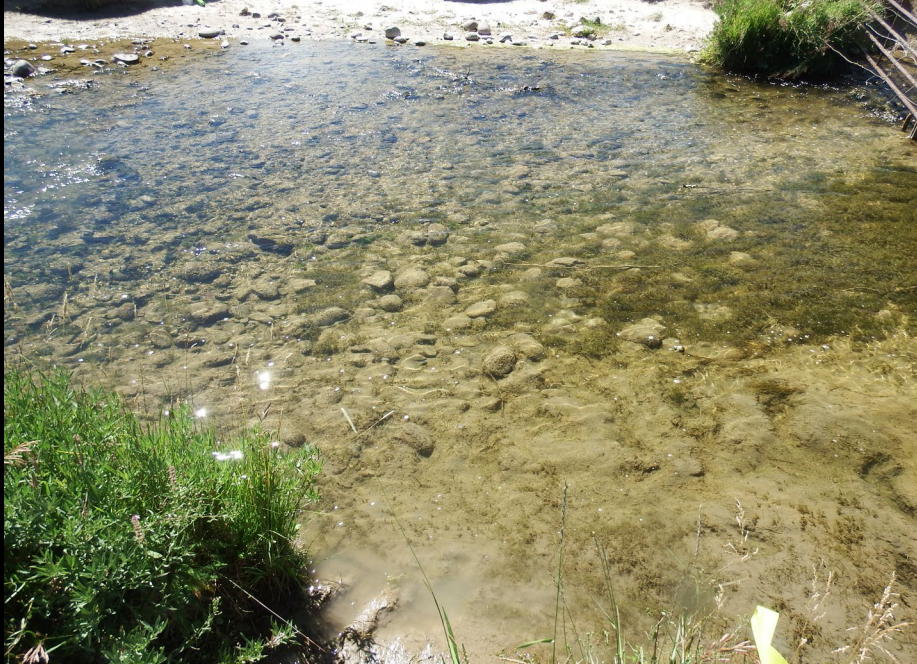
Observed Condition

% Fine Sediment < 2 mm in Pool Tails (Where fish Spawn)

Expected: < 17%

Measured: 27.5%

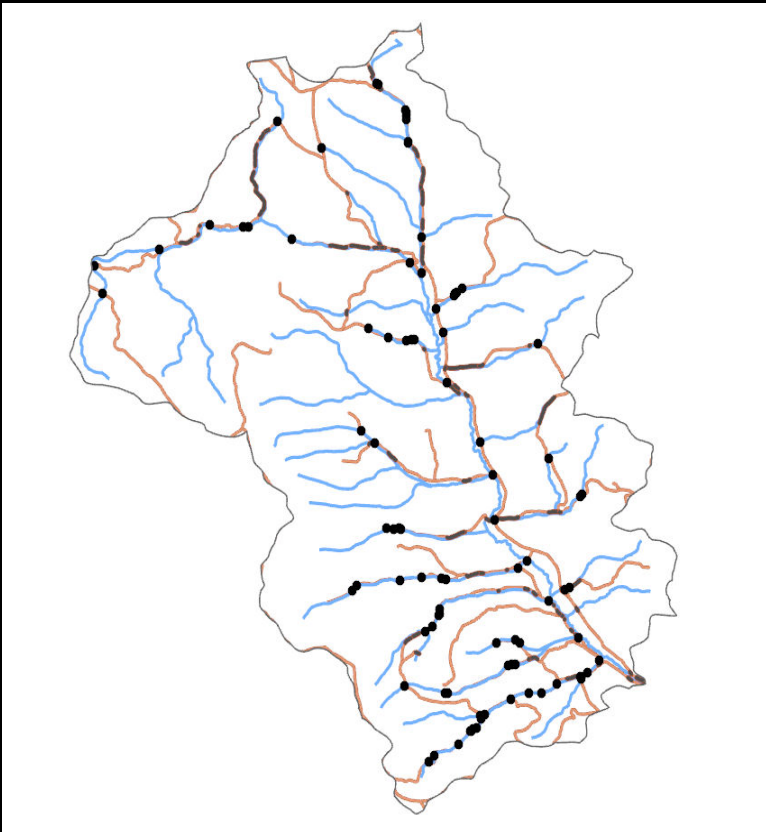
High Density of Road Crossings  
Muddy Creek

- GIS estimates of number of road crossings and adjacent segments of road
- Extrapolated sediment loads based on knowledge of road practices

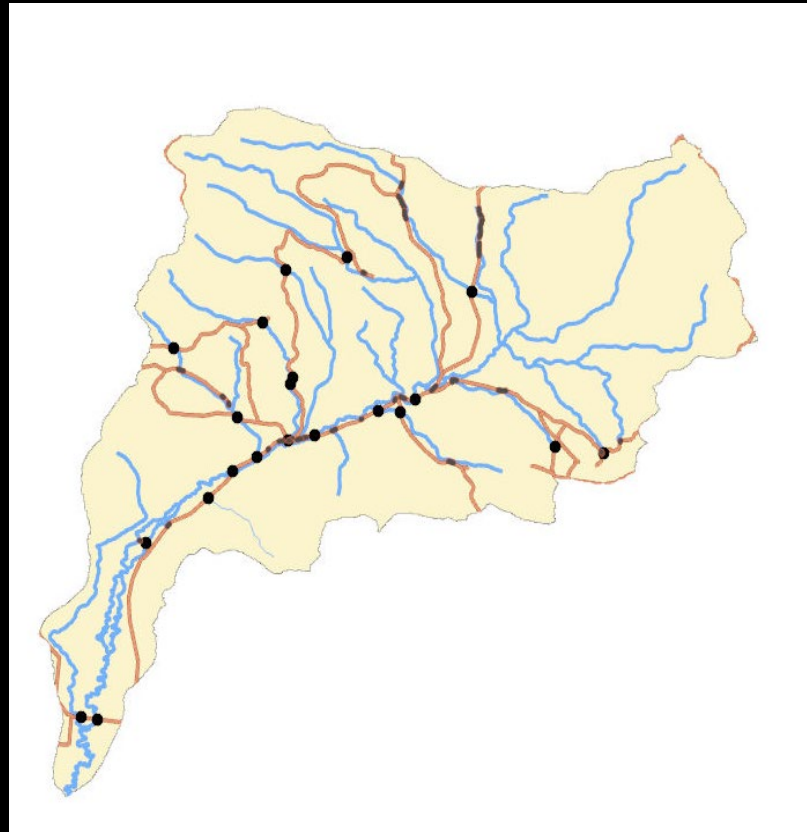
Low Density of Road Crossings  
Long Creek

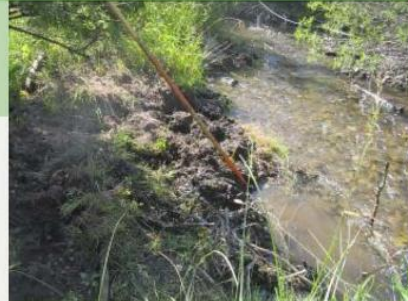
The excess fine sediment loading at the upper DEQ-monitored site (ATLP 04-02) is linked to riparian grazing in the form of trampled streambanks and over-widened areas of the stream from cattle crossings.

A trampled streambank from cattle access at monitoring site ATLP 04-02

Riparian area improvements in the form of grazing best management practices could eventually result in reducing sediment loading enough to meet the water quality standard. The DEQ-monitored site on lower Antelope Creek (ATLP 10-01) demonstrated stable streambanks and a recovering riparian area due to a more recent fencing project and hardened stream crossing that has reduced livestock access to the stream.
